# Replacement vs. Refurbishment

The Ford Centre, Minneapolis, MN

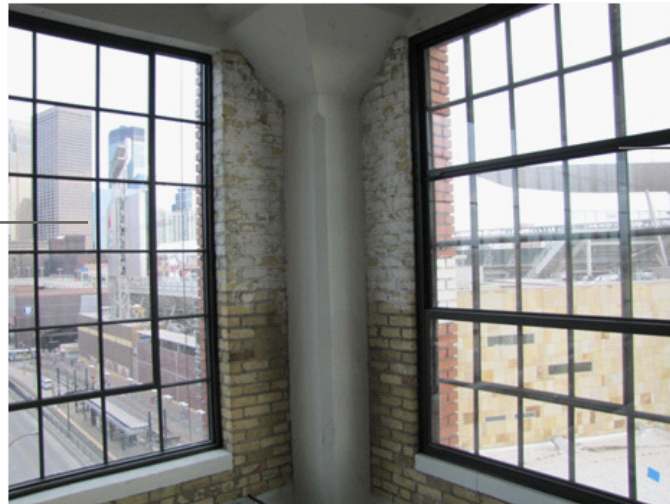
Series 2500 from  
St. Cloud Window, Inc.

The Ford Centre of Minneapolis, MN had a number of existing steel windows replaced with storefront many years ago. When undertaking the most recent renovation, the original windows were removed, restored and reinstalled from the first floor and up, filling as many openings as possible with refurbished windows. When all original windows had been used, the remaining openings received Series 2500 Historic Steel Replication windows manufactured by St. Cloud Window, Inc. which were based off of the design and sitelines of the original steel windows and passed historical review.

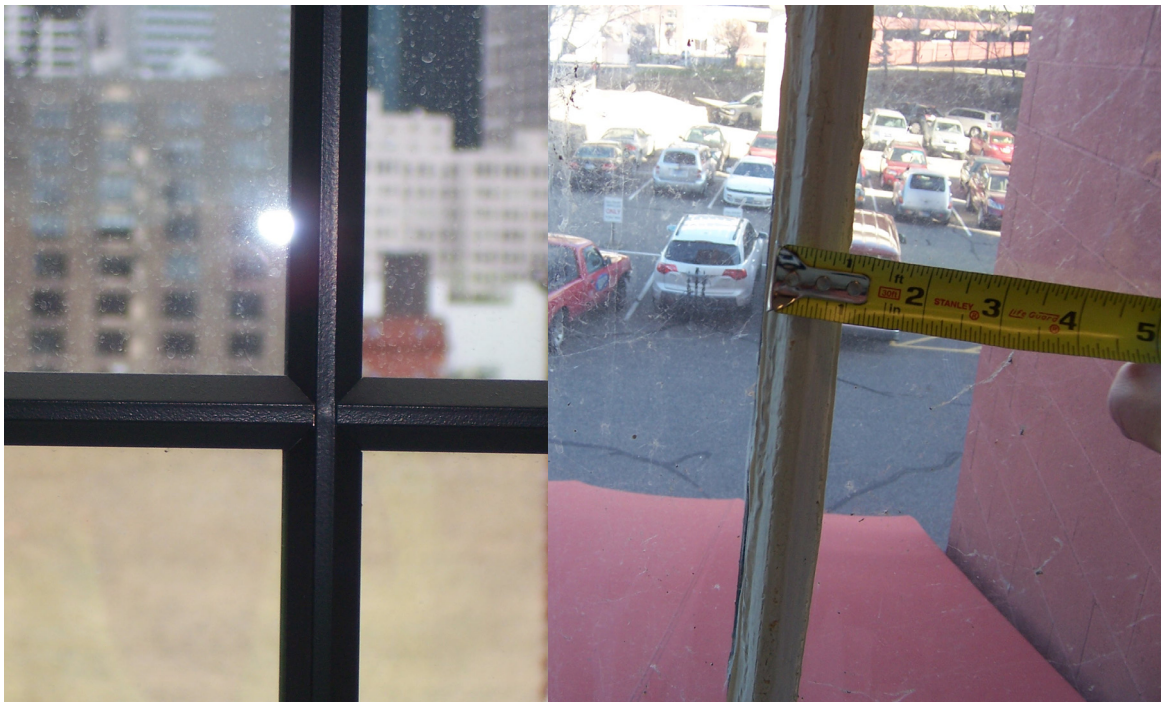
Refurbished

The original window muntin sightline was 7/8".

The muntin provided by St. Cloud Window, Inc. matched the exterior profile and overall dimension.

Series 2500

Original

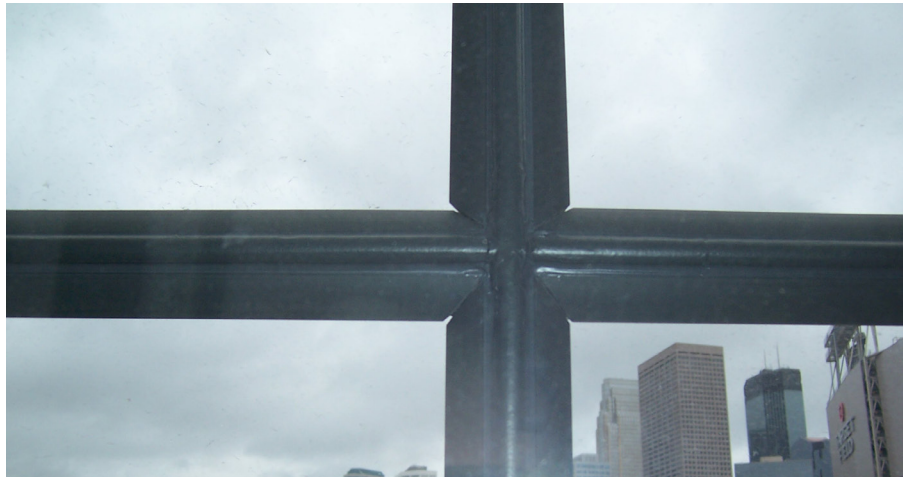
The refurbished muntin grids ended up at an overall dimension of 1-1/2". The contractor used a vinyl stop and silicone for reglazing and the glass was 1/4", non-thermal glass with no low 'e'.

The sightline increased due to the need for setting blocks, common sizes and to accommodate the stop system that was utilized. In order to achieve the thermal goals for the project, an interior storm window system provided by St. Cloud Window, Inc. (SCW620 Hung) was used on the interior of all refurbished windows.

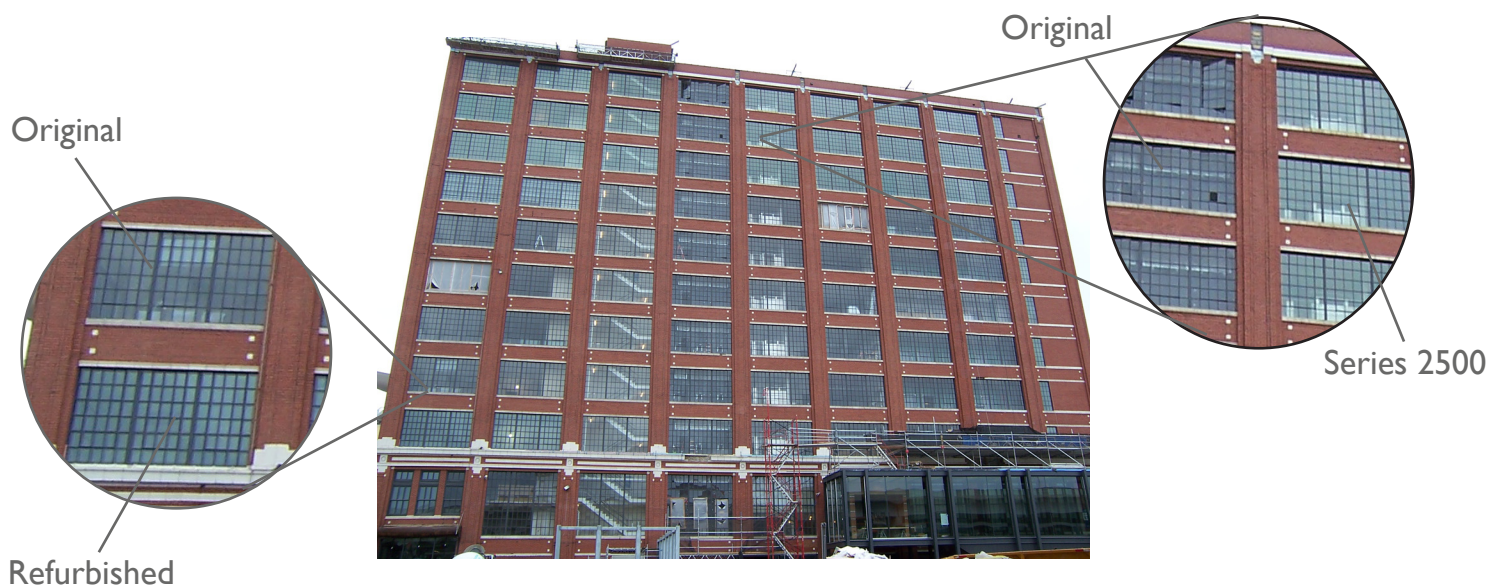
Refurbishment does not always successfully meet the intended goals of historical renovation. Had the project incorporated an IG unit in lieu of monolithic glass, the sightline would likely have been larger due to the need to "hide" and protect the IG spacer to prevent seal failure.

In this particular building, the replacement windows do a better job of representing the original building's windows than do the refurbished windows.
